STS-112
FLIGHT READINESS REVIEW

September 17, 2002

Ground Operations

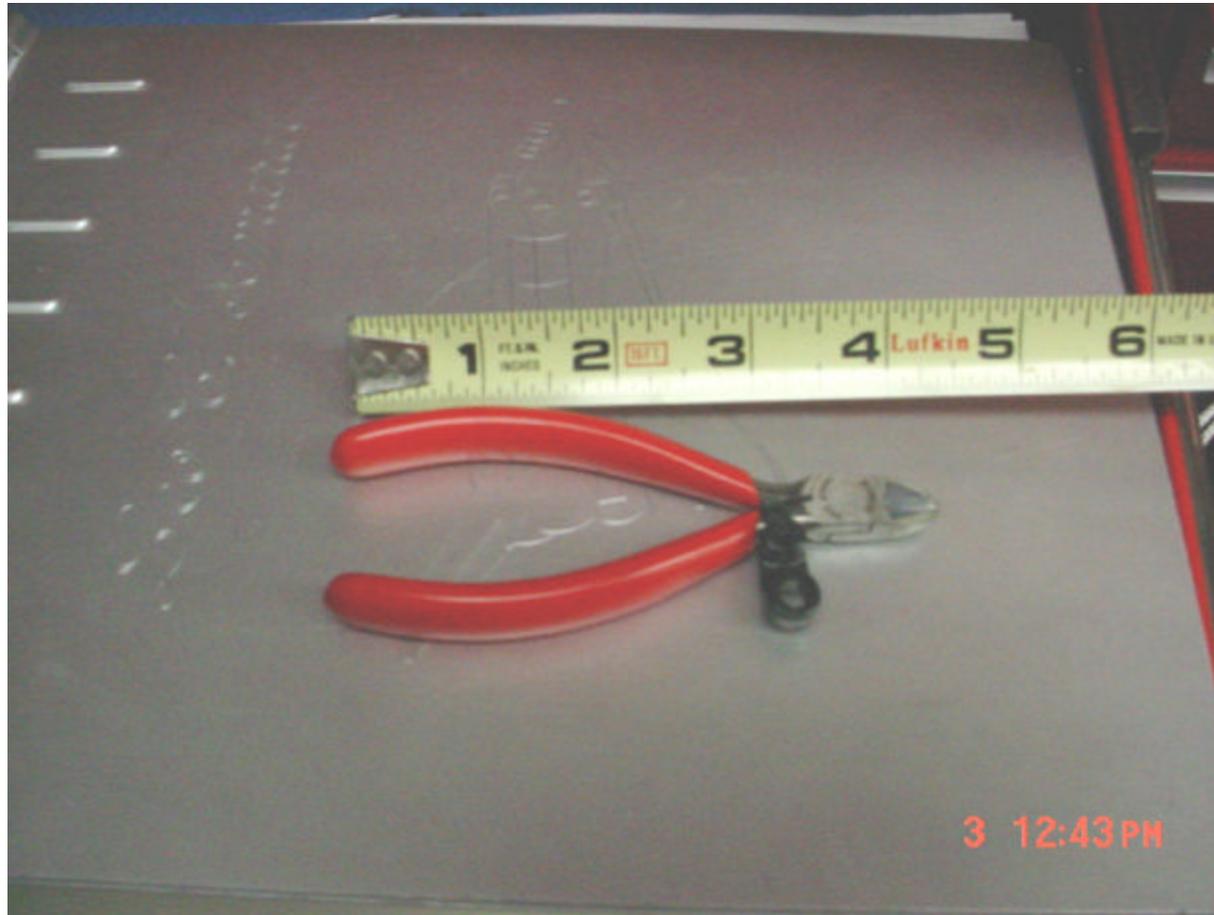
- Observation
 - On 5/29/02, a 3/8" True Flush Wire Cutter was identified missing after completion of an OEL task in the Aft Compartment of OV-104 from a Serialized Tool Box
- Concerns
 - Sharp edges and mass of this tool may cause damage to orbiter systems and components in the aft compartment

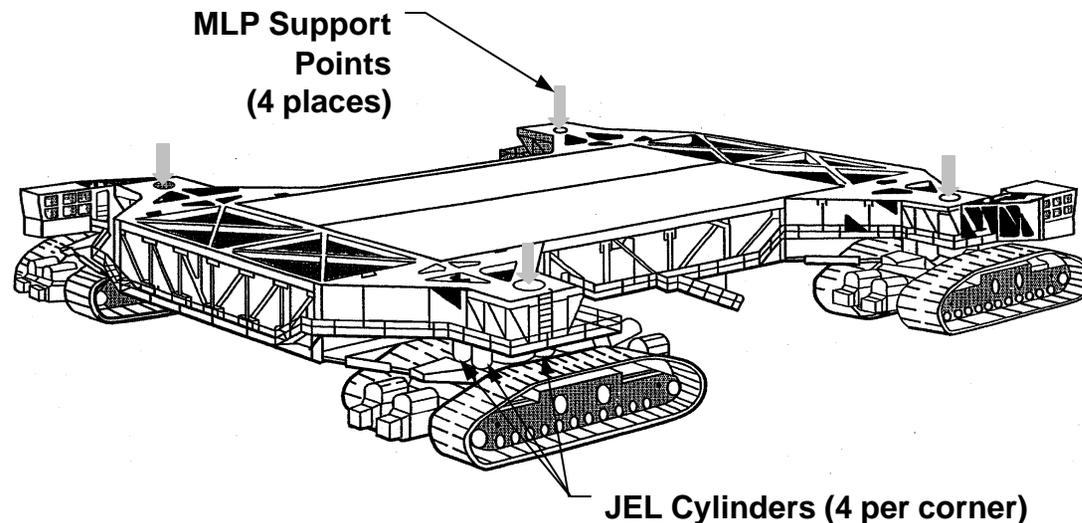
- Two JEL (Jacking, Equalization, and Leveling) Cylinders were removed from CT-2 as the beginning of a planned refurbishment program
 - Disassembly revealed that three of the four spherical bearings were severely cracked
- **Inspection of all 32 cylinders showed 30 of 64 bearings were cracked or broken**

- Current design determined to meet load requirements
- New and undamaged bearings installed with enhancements
 - New lubricant utilized with superior properties for application (Caterpillar Desert Gold Grease)
 - Method developed to mitigate rotation and augment press fit using Loctite 660, Quick Metal
- Repair meets original Crawler Transporter design and cycle life
 - Allows ample time for Design to evaluate modern bearing designs for possible upgrade (2020 support)
- CT-1 repair is In-work – ECD 11/02
 - Available for emergency use within 48 hours
- CT-2 Repaired, supported STS-112 roll to Pad and is Operational

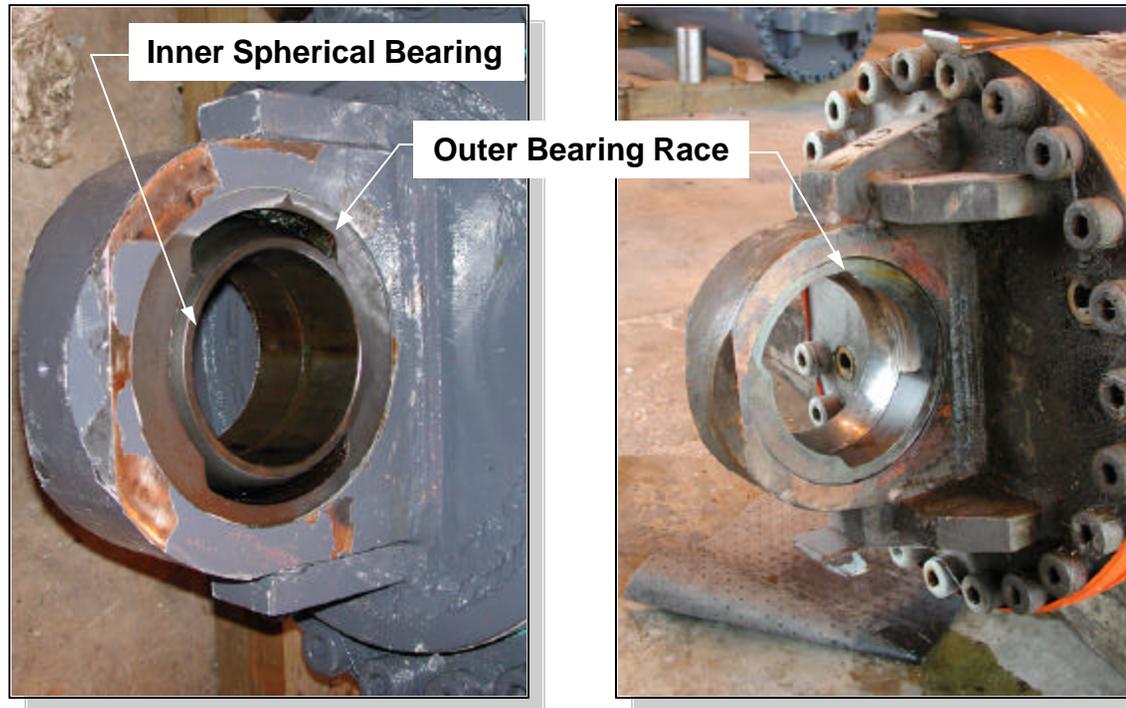
- Loss of lubrication in bearing load path caused outer race to rotate

- Bearing failed due to overload configuration

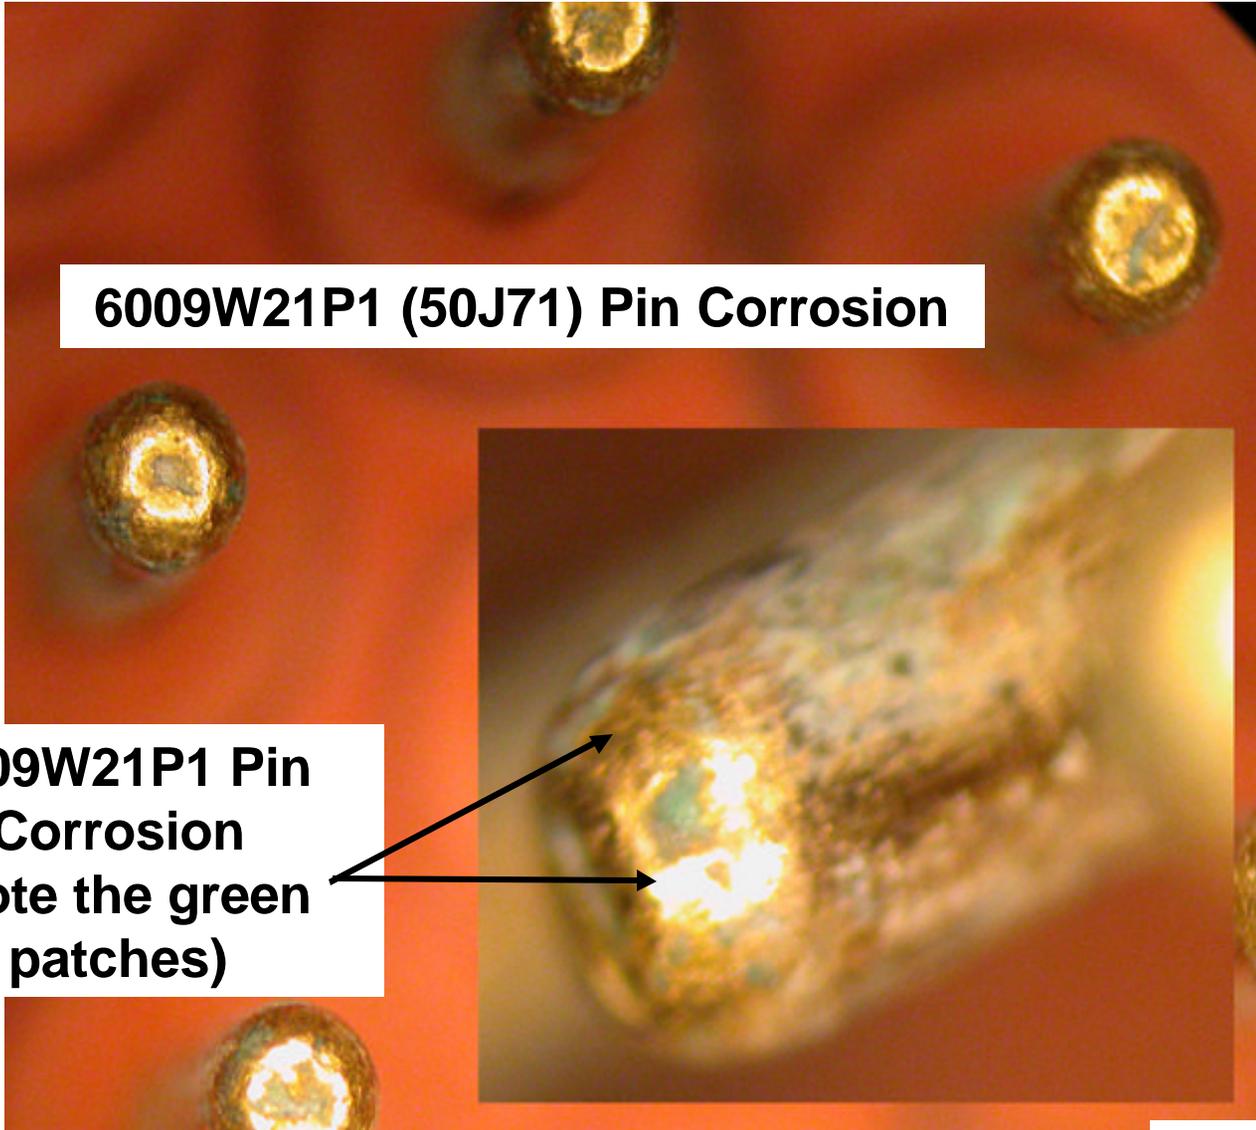
6009W21P1 (50J71) Pin Corrosion

**6009W21P1 Pin
Corrosion
(Note the green
patches)**

- Failure Analysis (Cont'd)
 - The connector saver, MLP3 connector 6009W21P1 and 2 ft of cable were cut off from the 120 ft cable and sent to the NASA MAB Lab for failure analysis
 - Preliminary Lab report shows extensive corrosion/contamination on the pins in this connector, including those carrying the LDB1 signal 'GG' & 'HH'
 - Major contaminants were composed of Al, Si, Cl, Ca, and 'Copper corrosion'
 - The fine gauge wire was also confirmed near but not touching pins 'GG' and 'HH' (See next few pages for photo's of debris)
 - The connector saver, connector, and cable stub were subjected to an Insulation Resistance Test and continuity testing with wire contamination present
 - Passed all testing conditions at (500V IR @ 100 Mohm)
 - Could not duplicate the exact LDB1 failure signature

- Cause is believed to be the corrosion found by the MAB lab on the pins of the GSE Connector 6009W21P1

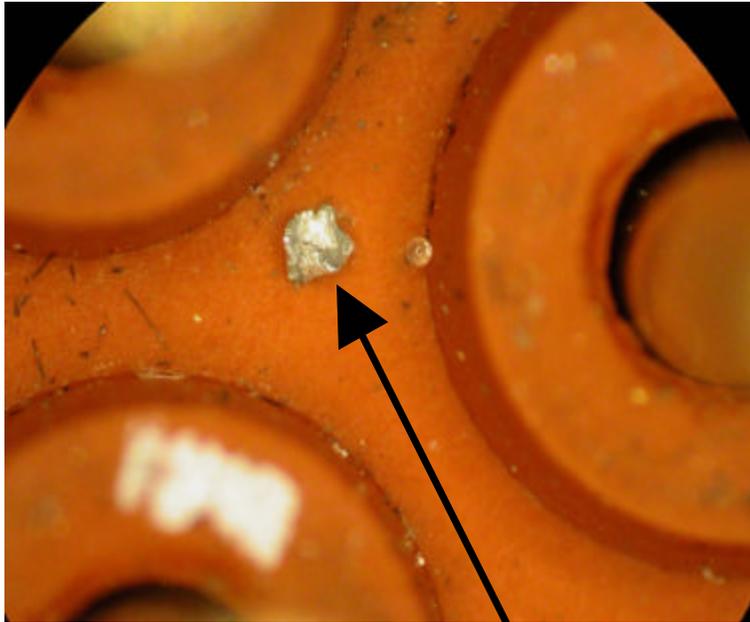
Metallic
Debris/Reflector bead
in connector saver

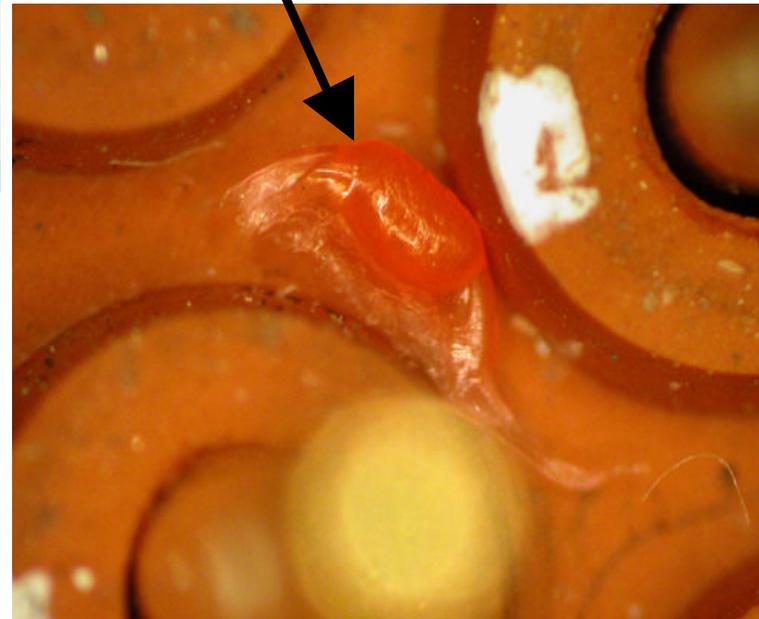
Connector Saver
– Inboard Side –
Plastic Debris

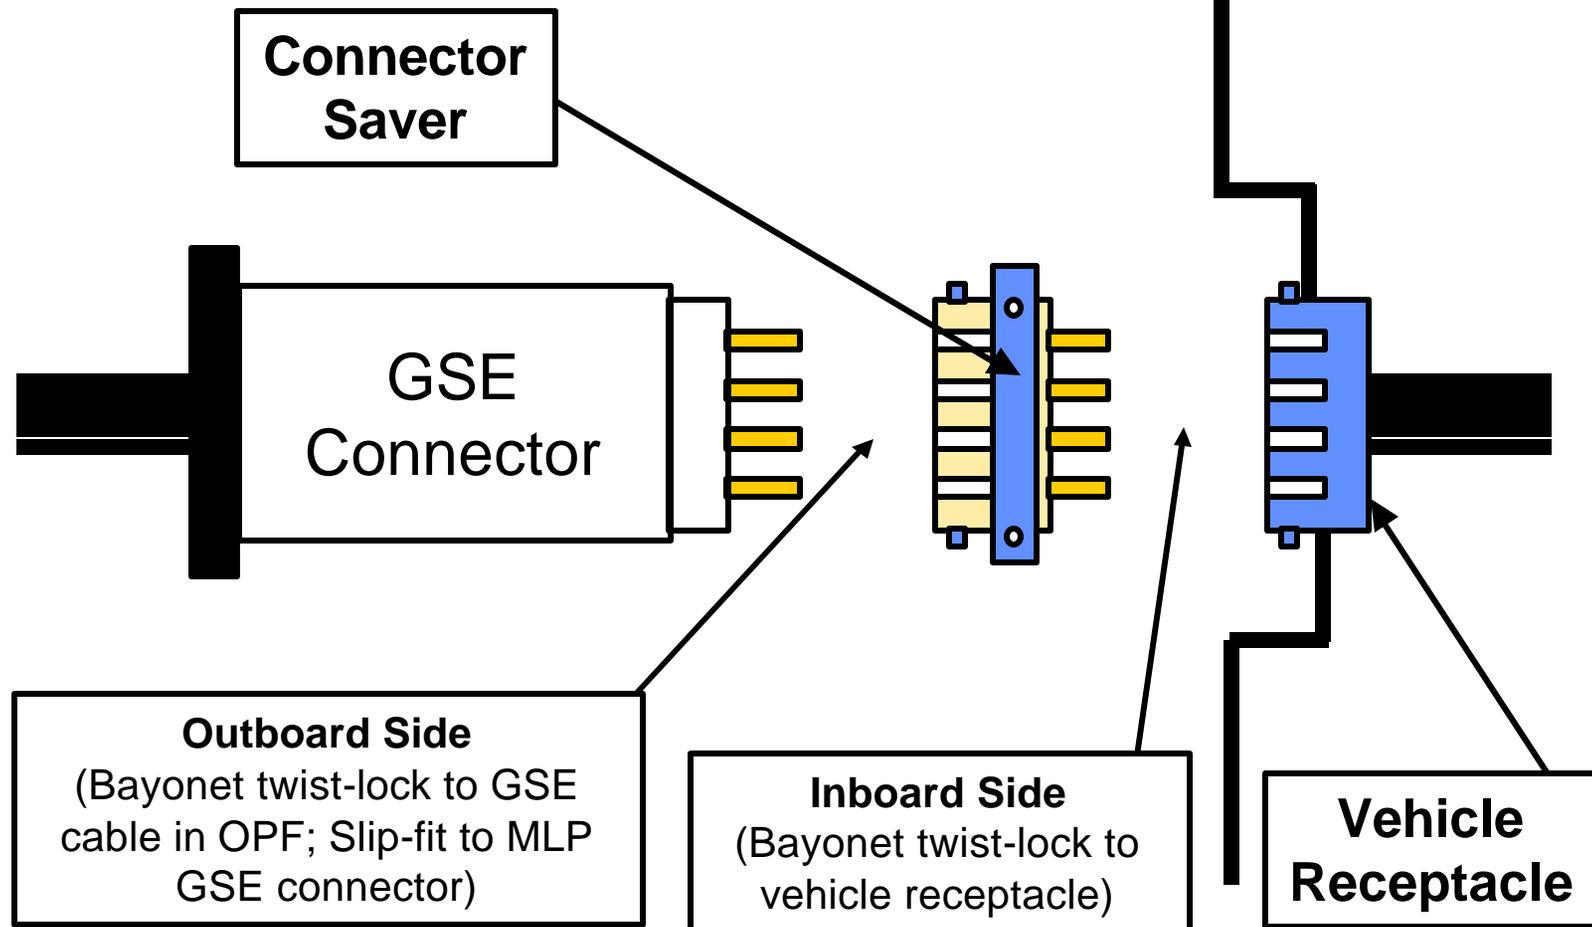
T-0 CONNECTOR PINS/SOCKETS ANOMALY – PROBABLE CAUSES:

- Possible Causes
 - An Intermittent copper path problem in the wiring between the 900686 TD and GSE Connector 6009W21P1
 - An intermittent in the onboard data bus wiring between the T-0 receptacle 50J71 and DBIA-1 in Av Bay 4
 - An intermittent electrical problem in the Data Bus Coupler (DBC) linking LDB-1 to DBIA-1
 - An intermittent electrical problem in the portion of the DBIA-1 that handles the LDB communication between LPS and the onboard GPC's
 - An Intermittent copper path problem between the outboard sockets on the vehicle connector 50J71 and the pins on the Connector Saver
 - An Intermittent copper path problem between the outboard sockets on the Connector Saver and the pins on GSE Connector 6009W21P1

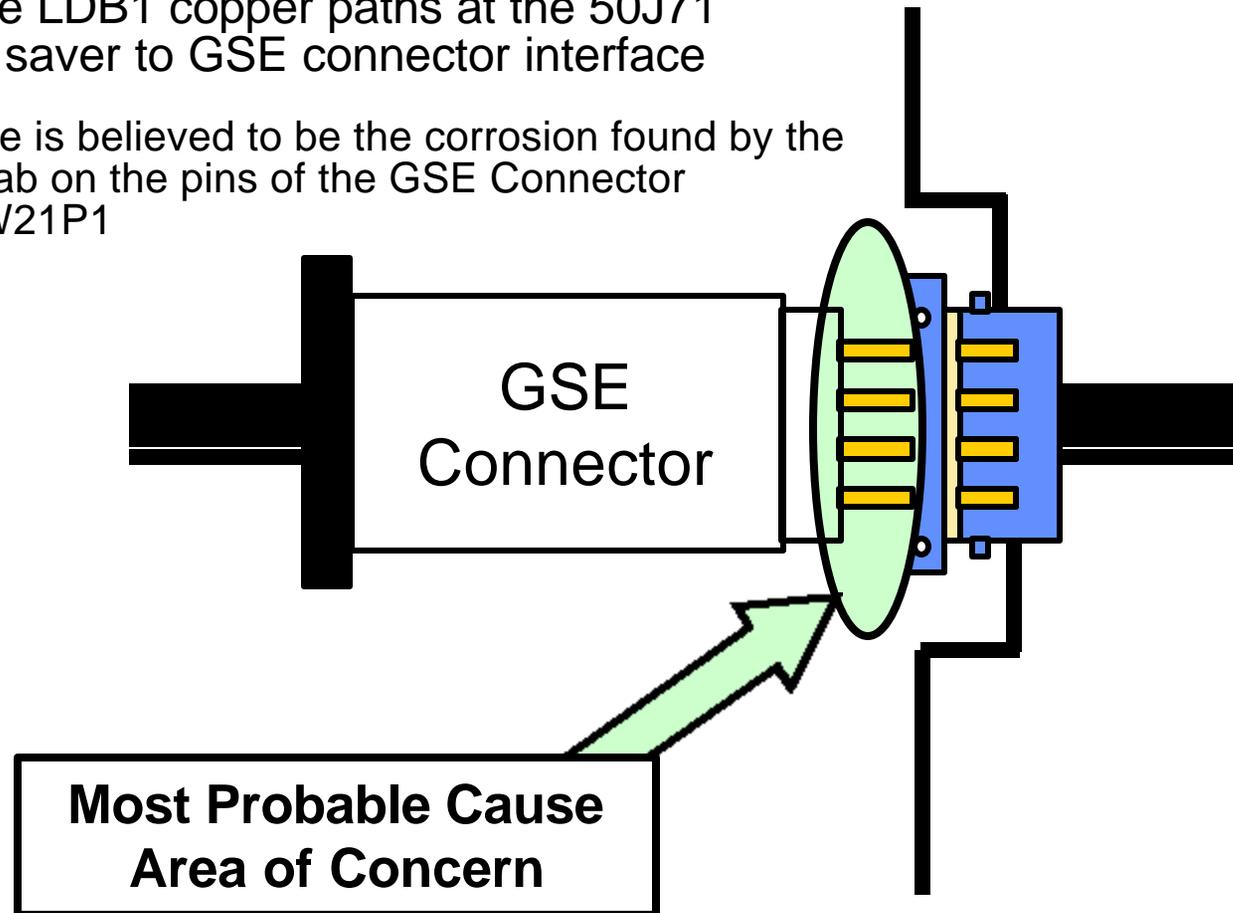
- Most Probable Cause

- An intermittent open or high resistance in one or more of the LDB1 copper paths at the 50J71 connector saver to GSE connector interface
